2. Title of microfiche (appears on each coordinate)

E 16	Product/assembly/test step Vehicle/engine

Technical Bulletin

Danger of Accident an Semi-canductar Ignition Systems

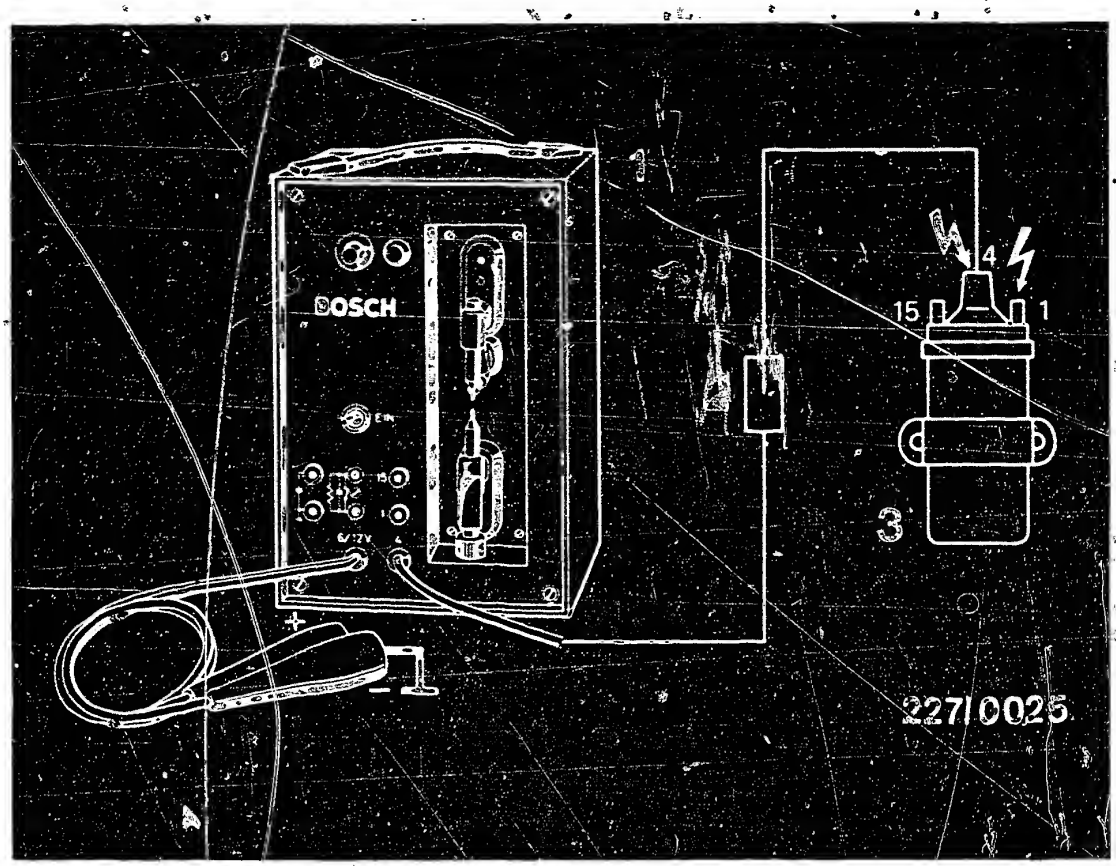
- In order to prevent the trigger box from being irreparably damaged, the secondary side of the ignition system must have at least 2 kΩ interference suppression.

- In order to prevent the trigger box from being irreparably damaged, when using a spark gap, an interference-suppression resistor of at least 2 kΩ must be connected between the spark gap and ignition coil terminal 4, e.g. sleeve-type suppressor (5 kΩ) 0 356 500 001.

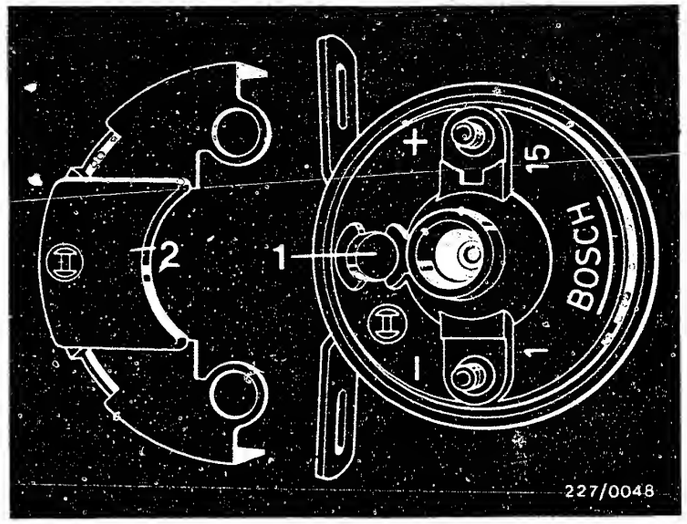
Visual inspection: Check whether the closure plug is present and whether sealing compound has escaped.

Is the closure plug still in place or has sealing compound escaped?
Resistance values OK?

1. If the closure plug is missing or sealing compound has leaked out, the trigger box and the ignition coil must be replaced.

2. If the resistance values are not OK, the trigger box is to be tested.

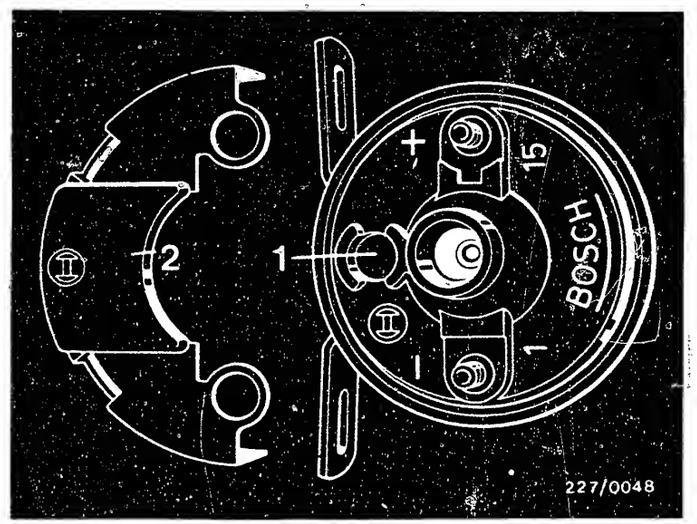
Visual check: Check that the closure plug is still in place and that sealing compound has not escaped.

Is the closure plug still fitted? Sealing compound has NOT escaped?

Resistance figures OK?

1. If the closure plug is no longer fitted or sealing compound has escaped, then the trigger box and the ignition coil must be replaced.

2. If the resistance figures are NOT OK, then the ignition coil must be replaced.

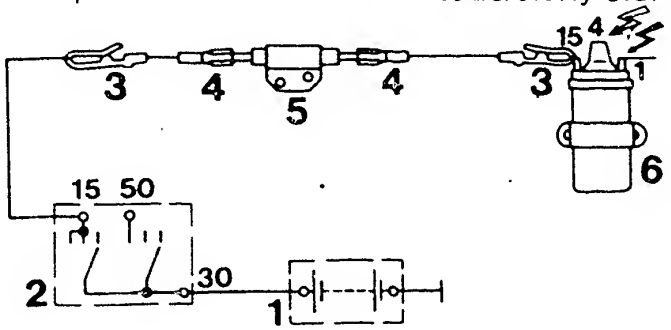
In comparison with conventional ignition systems, transistorized ignition systems with current limitation have different primary voltage characteristics. During the dwell period the voltage at terminal 1 of the ignition coil may assume values from 1.5 V to battery voltage (or greater). This may lead to an incorrect display of rotational speed and dwell angle when testing the ignition system. However, there is no functional defect in the ignition system, and, for this reason, the trigger box must not be replaced. Incorrect displays may occur with the testers listed below:

Connect a ballast resistor of 0.9 or 1.0 Ohm (see Fig.) in series in the line to term. 15 of the ignition coil (take care not to cause a short circuit). After the rotational-speed measurement, the ballast resistor must be removed (otherwise starting difficulties and misfiring). Connect tester as per operating instructions.

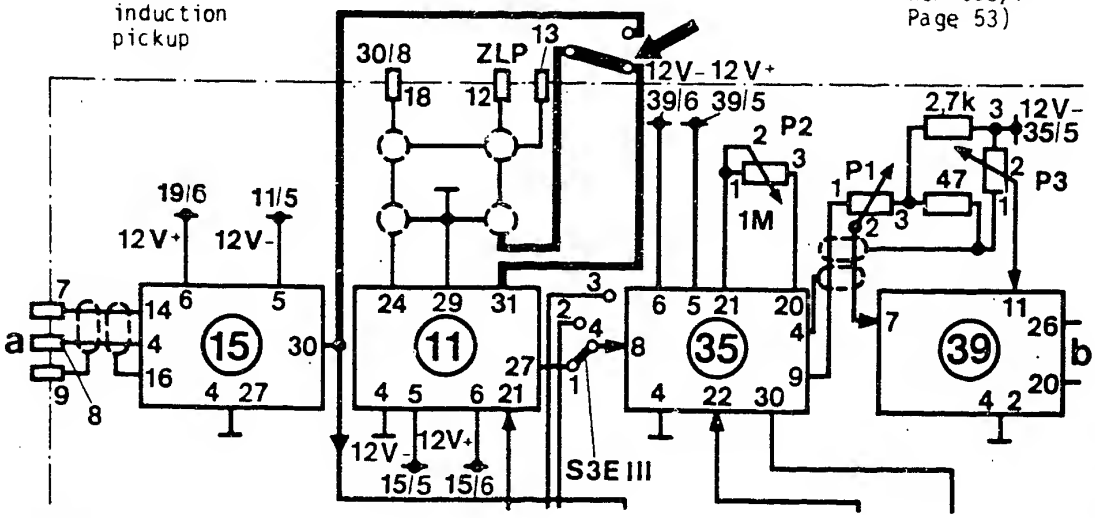
EFAW 214 B

In comparison with conventional ignition systems, transistorized ignition systems with current limitation have different primary voltage characteristics. During the dwell period the voltage at terminal 1 of the ignition coil may assume values from 1.5 V to battery voltage (or greater). This may lead to an incorrect display of rotational speed and dwell angle as well as to incorrect triggering of the meter when testing the ignition system. There is, however, no functional defect in the ignition system, and, for this reason, the trigger box must not be replaced. Since, with the above-listed motortesters, the timing light is triggered by the signal path dwell angle - meter, this incorrect triggering also leads to incorrect flashing and thus to an incorrect display of the advance angle.

Remove the line from terminal 6 of printed board 16 to pin 31 of printed board 2 (coupling stage) and connect to pin 24 of the same printed board via a switch with change-over contact (e.g. 0 341 500 803). In addition, a new line must be connected from pin 31 of printed board 2 to the other contact of the switch with change-over contact. Arrow points to switch with change-over contact.
